**HOUSATONIC RIVER BASIN
SEYMOUR, CONNECTICUT**

**MIDDLE RESERVOIR DAM
CT 00590**

**PHASE 1 INSPECTION REPORT
NATIONAL DAM INSPECTION PROGRAM**

APRIL, 1980

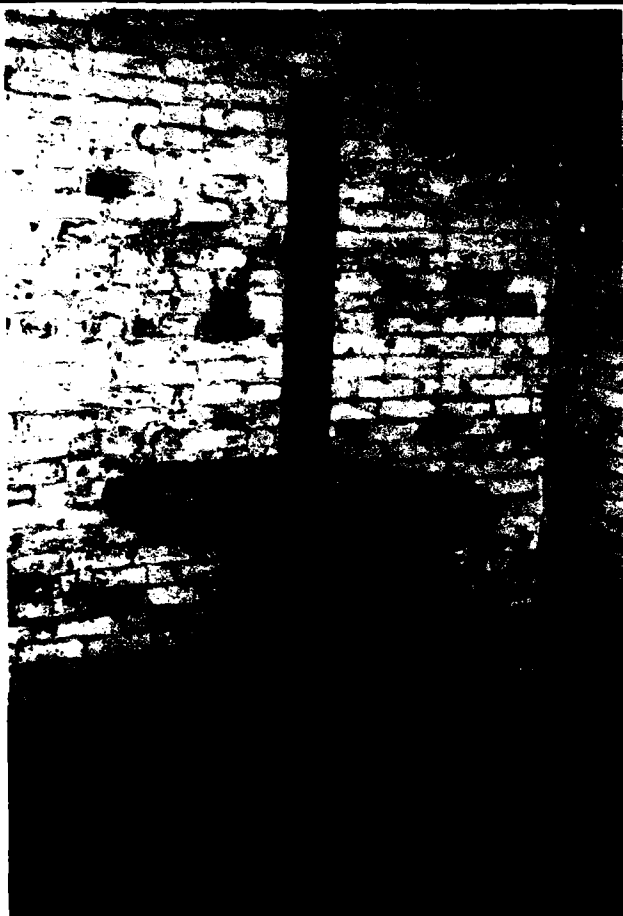
No regular maintenance of the gate house valves was reported. The lift mechanisms appear in good working condition. The control hydrant used to discharge water from the 8 inch blowoff is operated on an annual basis.

C-11 LIFT MECHANISM FOR
30 INCH GATE VALVE --
INSIDE GATE HOUSE
